TECHNICAL  
BRIEF

**BARRIER SERVICE DAMAGE EVALUATION**

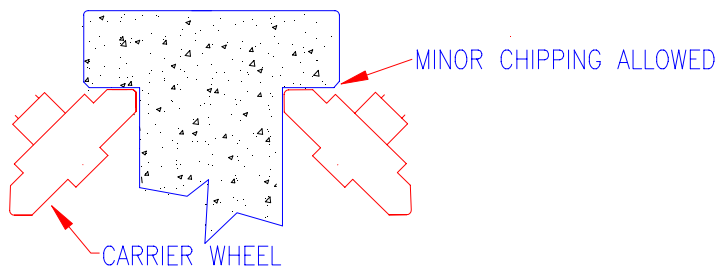
"T" TOP OF BARRIER IN CONVEYOR SECTION

Barriers that have been damaged in the chain must be replaced to preserve the structural integrity of the wall and to prevent damage to the machine. A barrier is deemed to be unsuitable if any of the following conditions exist.

- The barrier is damaged exposing any internal steel reinforcement.
- If more that 30 pounds of concrete is missing from any single area. A 30 pound piece would be about 7" x 7" x 7".
